FMU Pre Purchase Inspection

Sample PPI
2014 LAMBORGHINI AVENTADOR
VIN: xxxxxxxxxxxxxxxxxxxxxxxxxxxx
Odometer: 12748

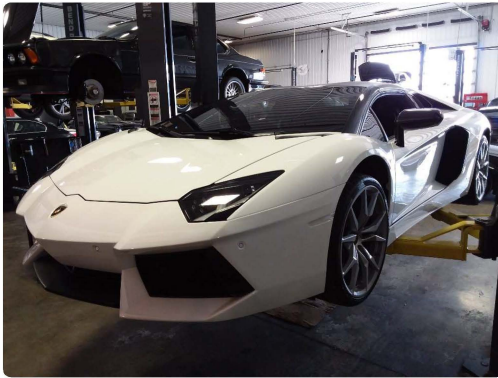
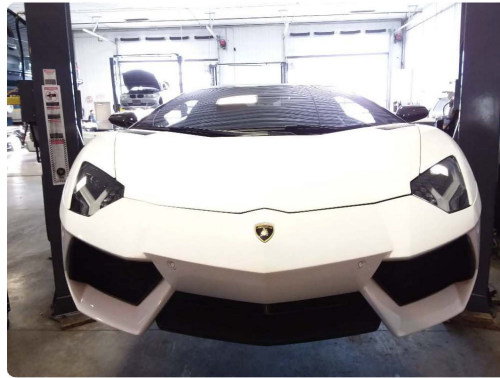
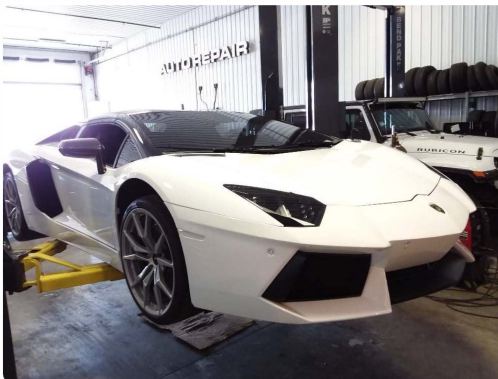
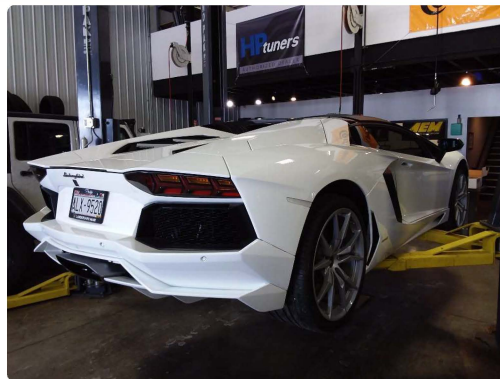
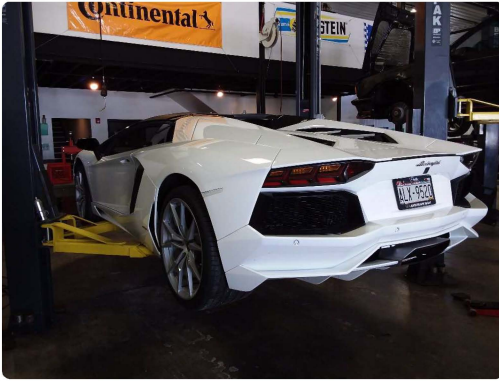
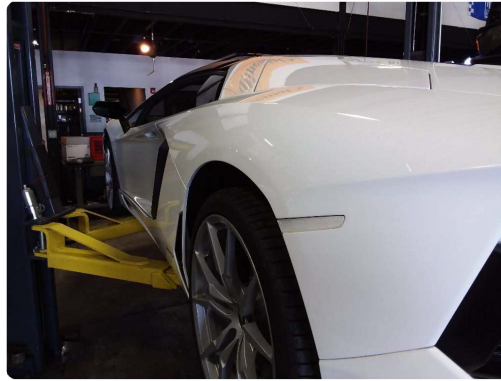
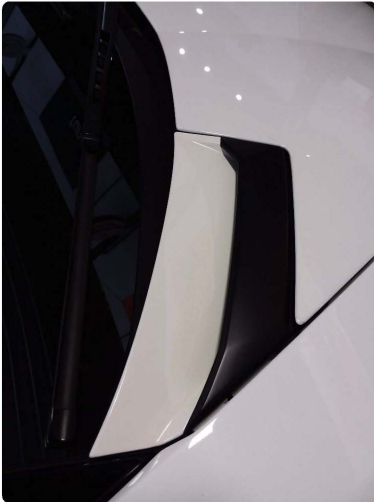
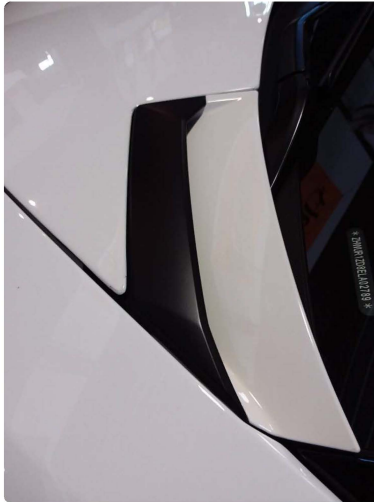
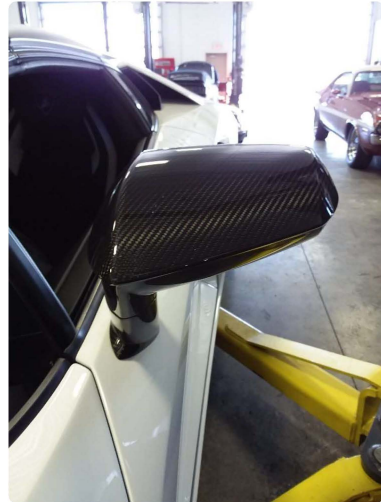
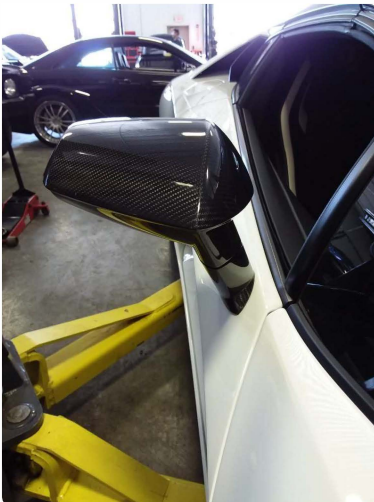
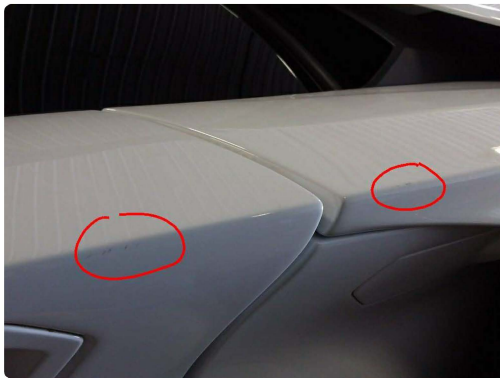
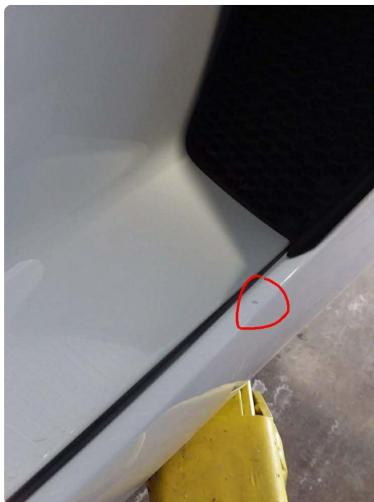
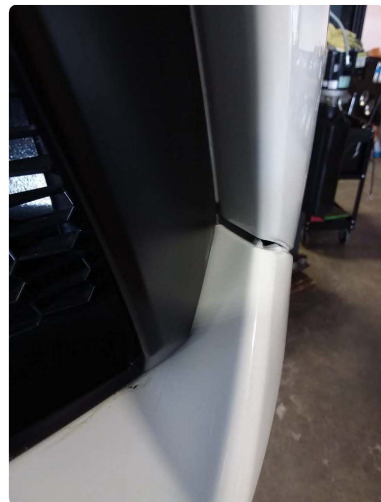
Exterior Condition Inspection

Technician Note: From a visual inspection, it does appear that some areas of the vehicle have been repaired. Meaning either repainted or air brushed in some areas like the following.. -Front bumper - Rear bumper -Hood -Door handles (See pictures and videos) The front bumper has scratches and shows signs of repair/being repainted. Also does not line up with fenders or hood. Underneath is heavily damaged with scraps and scratches (see pictures) The hood appears that it has a clear bra on it. The front fender liners are missing screws/not clipped. The rear bumper has some sections where clear bra was applied. Overall the body does have some imperfections. Small dings and scratches and shows signs of being repainted or air brushed in some places.

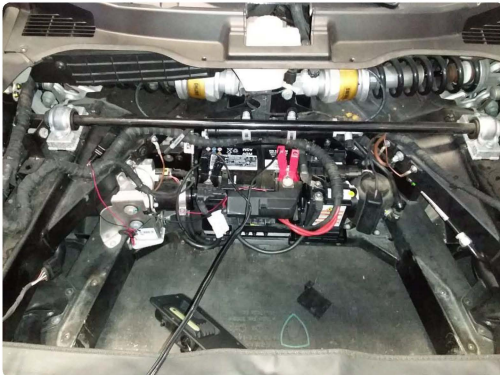
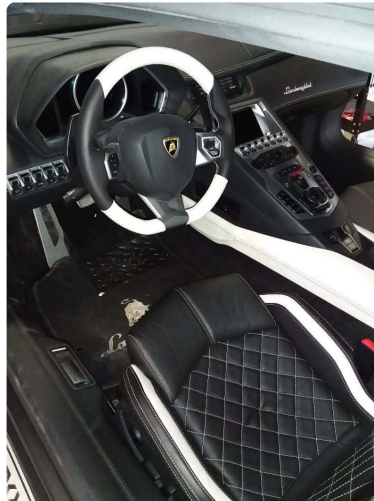
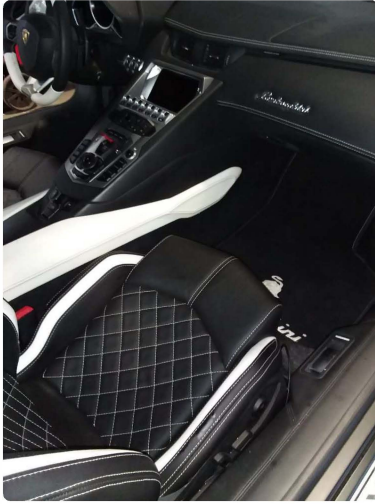
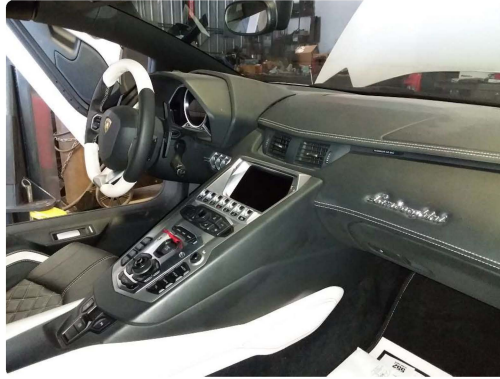
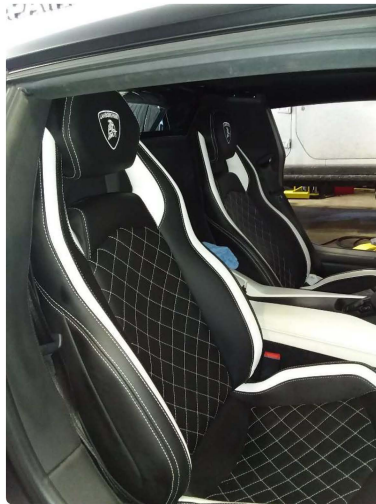
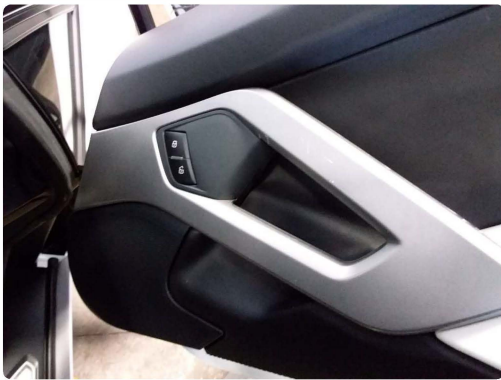
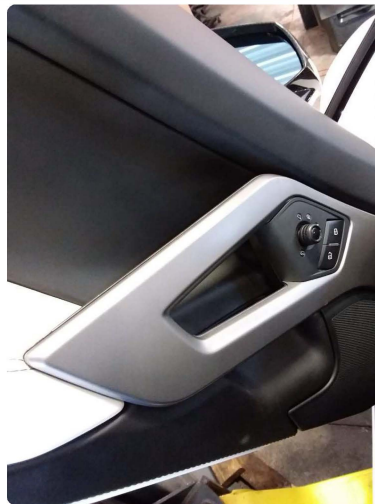
Interior Condition and Function Inspection

Technician Note: The overall interior condition is fair. It is showing signs of age and use in some areas. Scratches and Nick's in the center console. Wear in the seats Scratches on the door panels

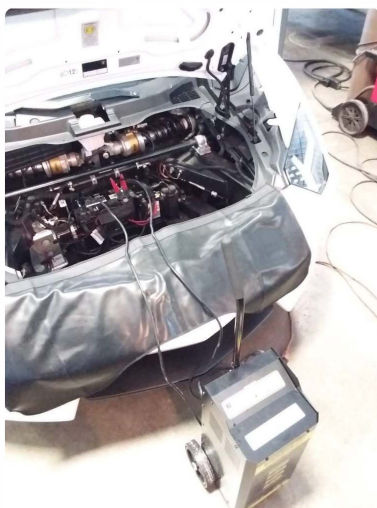
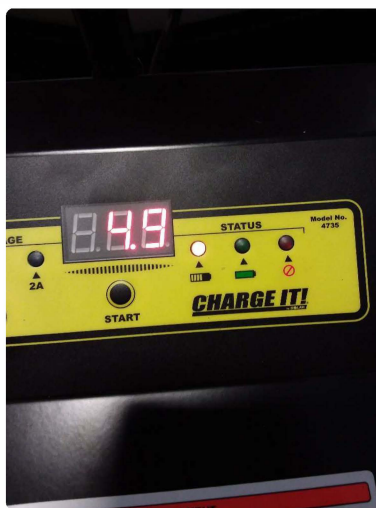
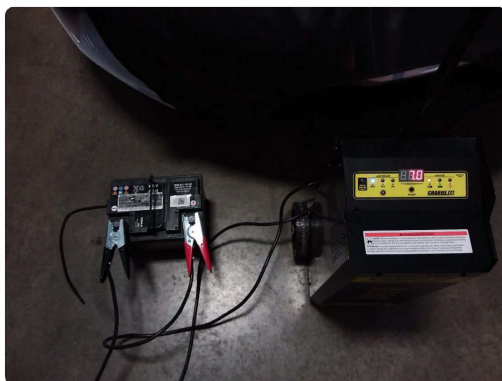
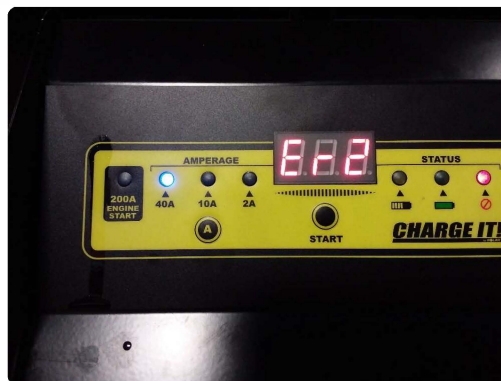
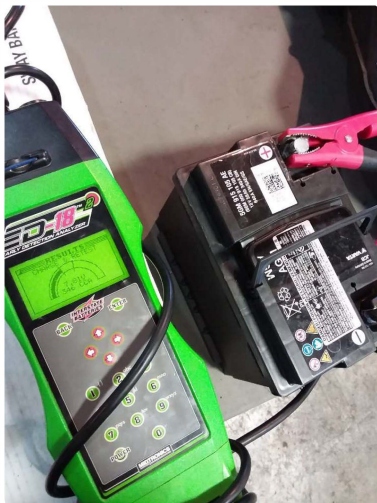
Battery Test

Technician Note: The vehicle was slow to start upon first inspection. Brought the vehicle in over night and the battery was drained. Vehicle would not start. Tried to test the battery but it didn't have enough power to power up the tester Original battery tested at 346cca Currently have a charger on the battery Battery will not hold a charge. Stamping indicates battery is from 2020 Battery and Starter have been replaced while the vehicle was here. The new battery and supercapacitor have been on a battery charging and are fully charged up.

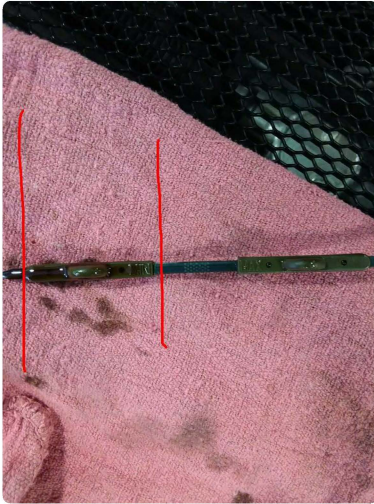
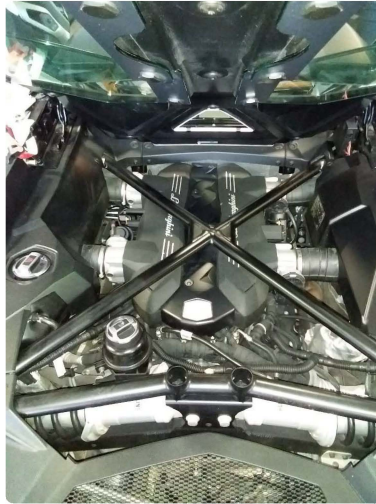
Inspect Engine Oil

Technician Note: ENGINE COLD level check. Right at the MIN mark

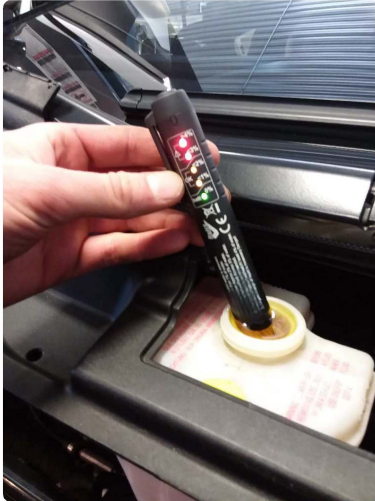
Inspect Brake Fluid

Technician Note: Fluid tested at: 4% The brake fluid condition is poor.

Recommendation: Brake flush recommended. Brake system is due to be flushed.

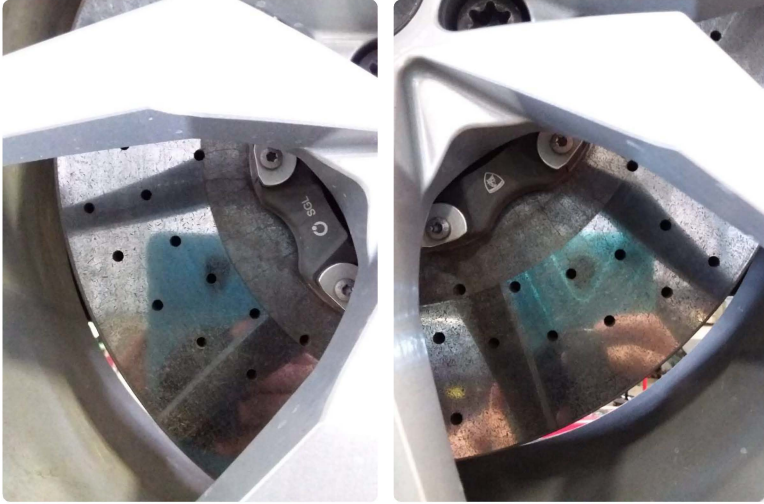
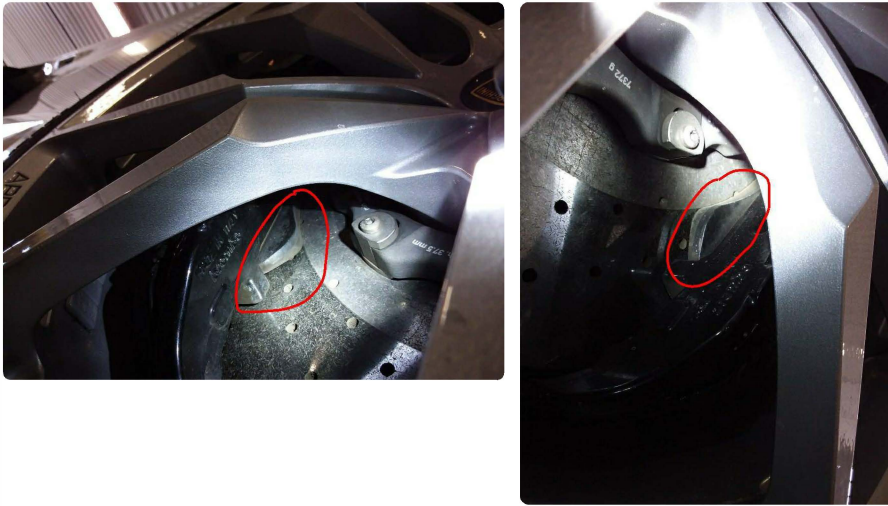
Inspect Front Brakes

Technician Note: Upon inspection of your front brakes we found your brakes are in good shape at this time. Front Brakes:8mm

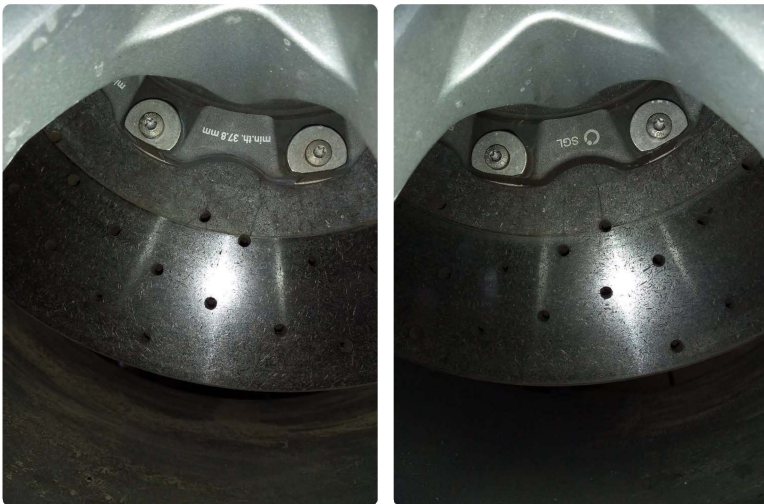
Inspect Rear Brakes

Technician Note: Upon inspection of your rear brakes we found that the brakes are in good shape at this time! Rear Brakes:7mm

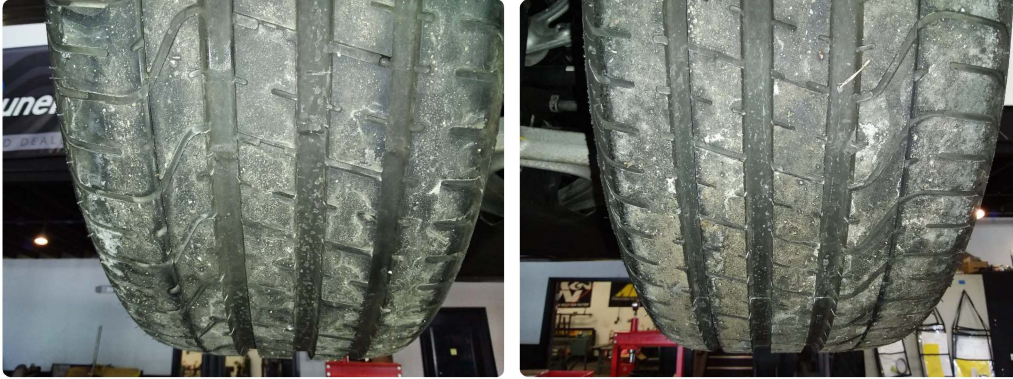
Inspect Tires and Set Pressures

Technician Note: Front left 8/32 Front right 8/32 Rear right 8/32 Rear left 8/32 Right rear tire was manufactured in 2020 Left rear tire was manufactured in 2019 Front right tire was manufactured in 2020 Front left tire was manufactured in 2020

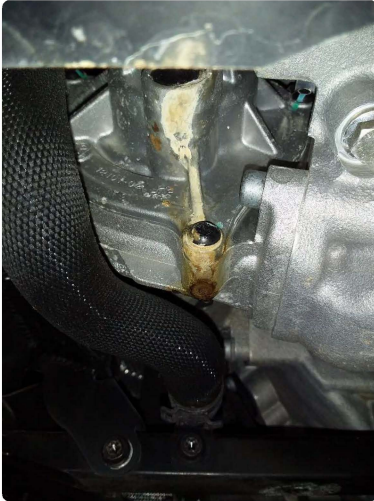
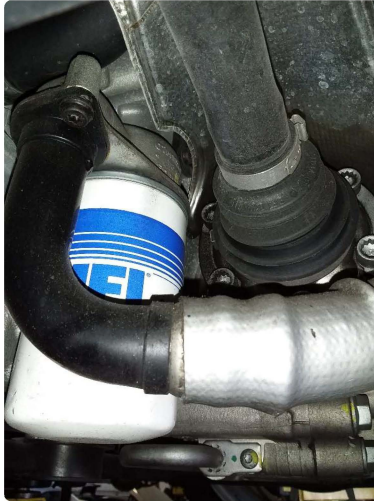
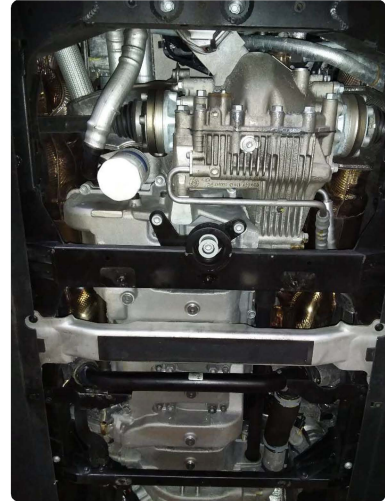
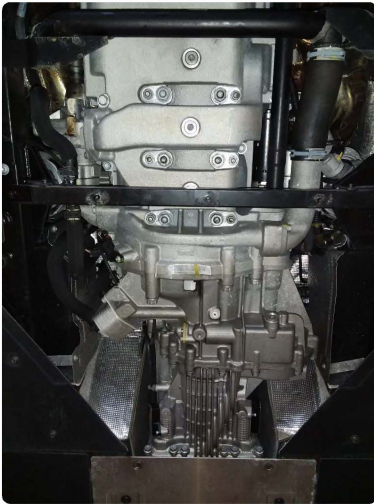
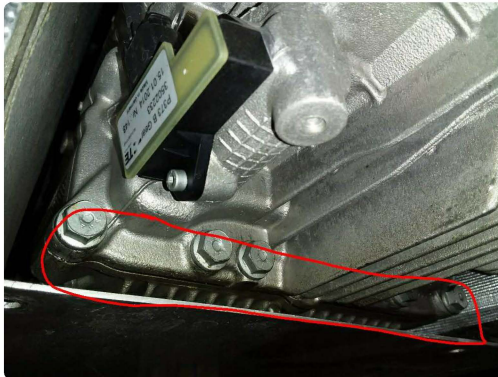
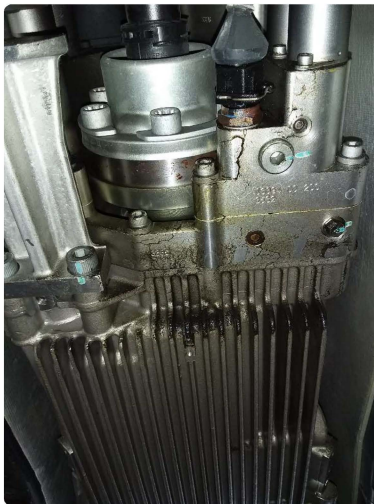
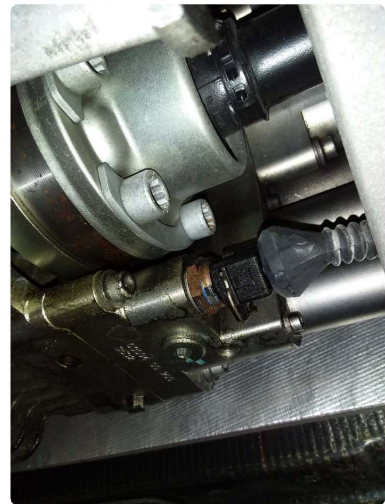
Fluid Leaks

Technician Note: The water pump appeared to have leaked/is leaking. There is dried up coolant on the plug on the water pump. No fresh drips or residue on the undertray. There is oil on the right rear axle but it appears it could be from the oil filter. Possibly not cleaned off from last service. The transmission casing appears to be seeping. (See pictures)
