FMU Pre Purchase Inspection

Sample PPI
2014 LAMBORGHINI AVENTADOR
VIN: xxxxxxxxxxxxxxxxxxxxxxxxxxxx
Odometer: 12748

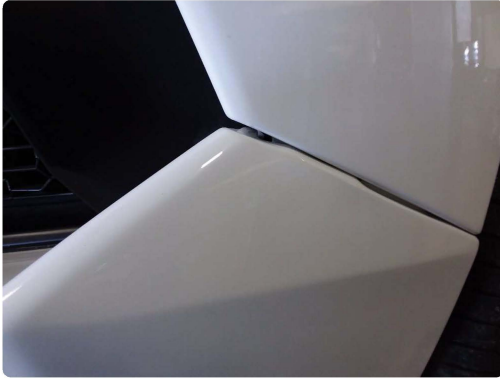
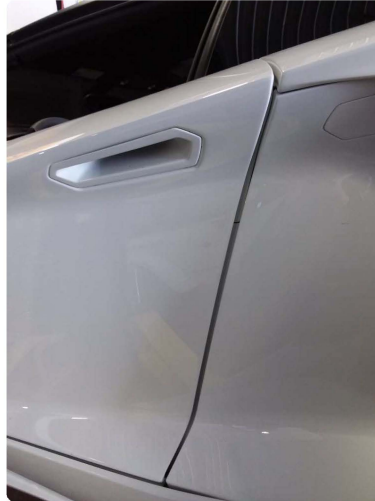
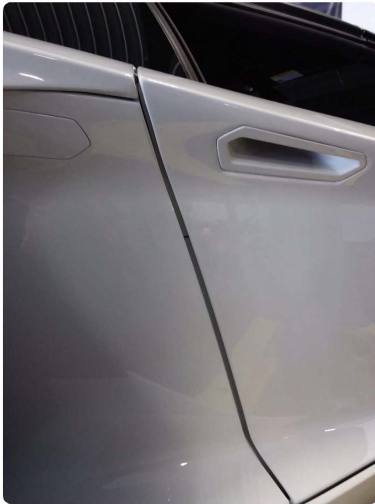
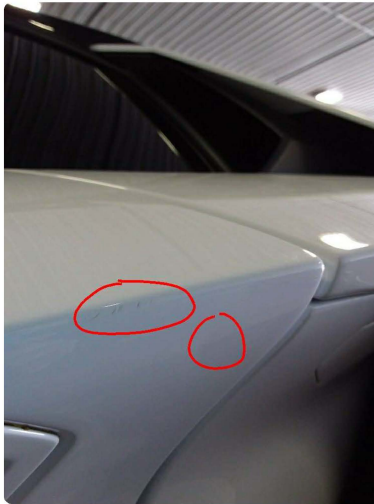
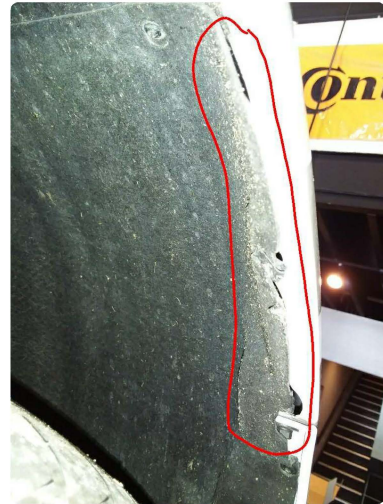
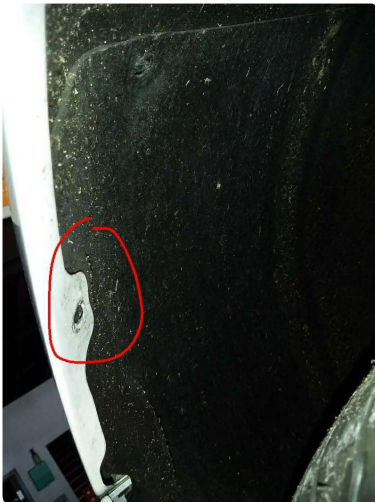
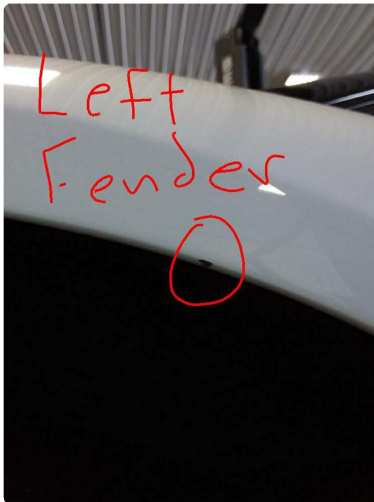
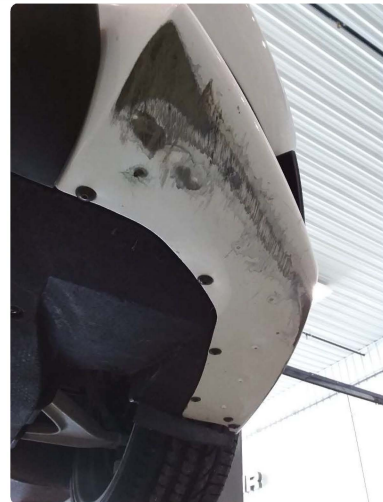
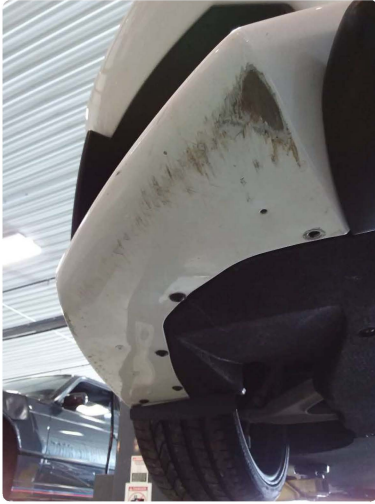
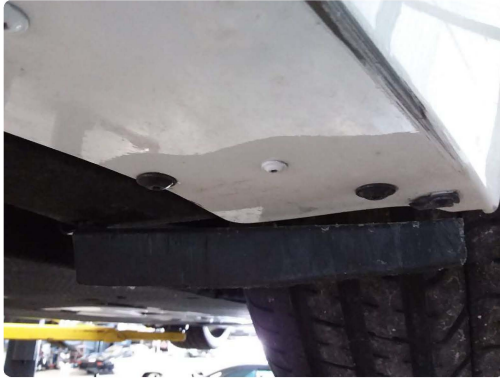
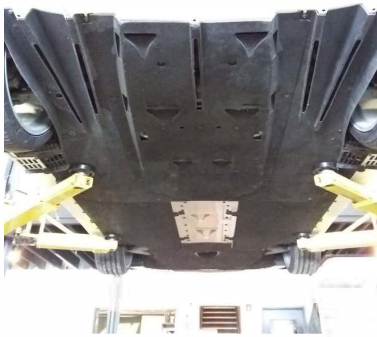
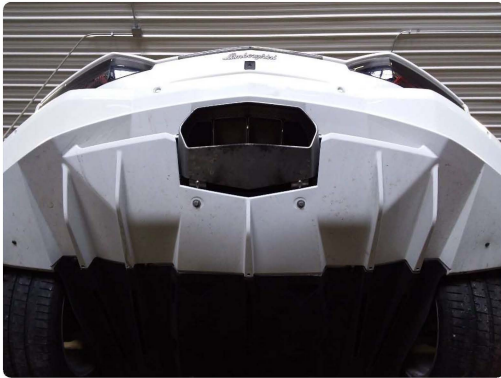
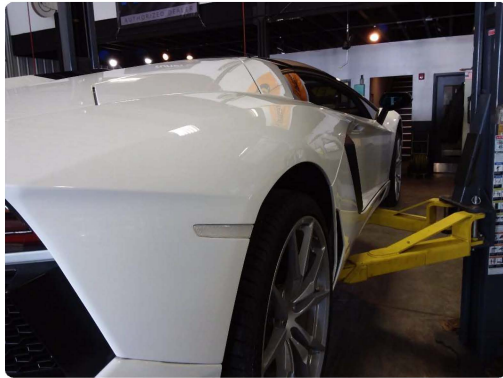
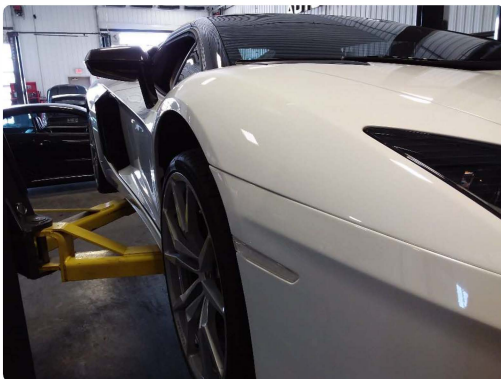
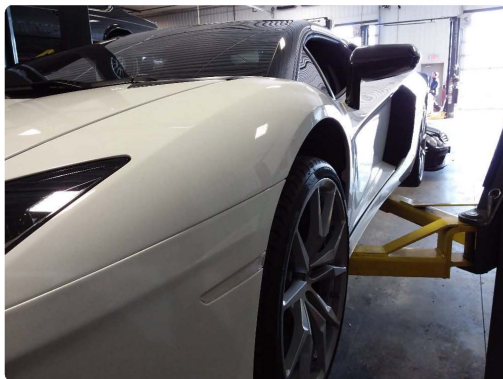
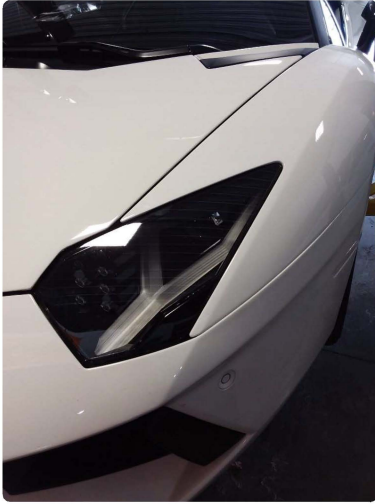
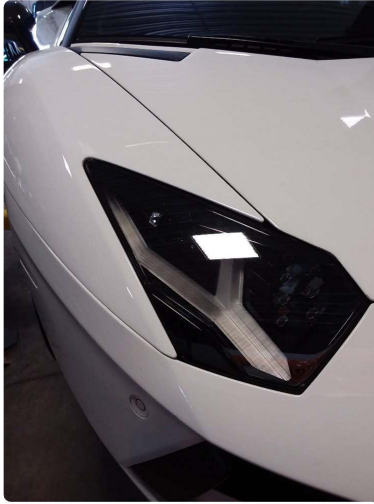
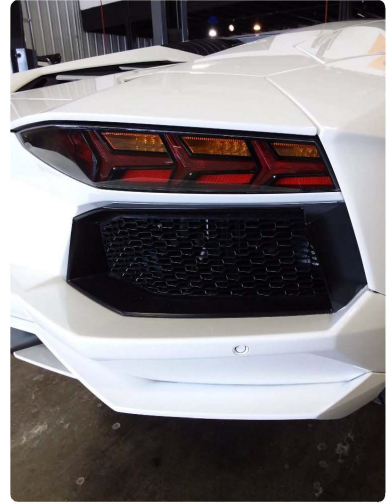
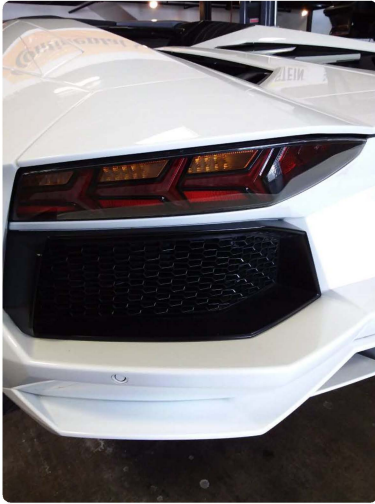
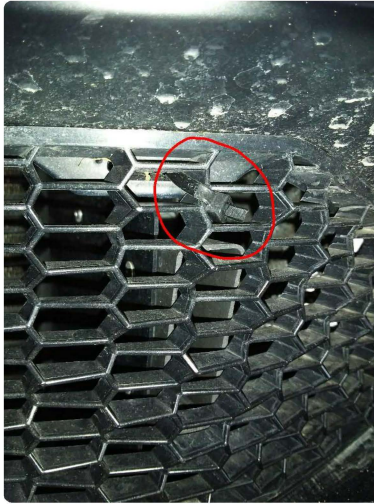
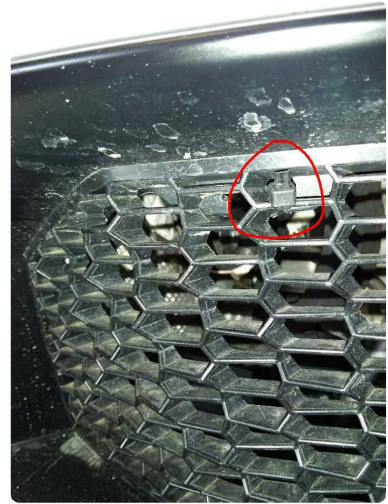
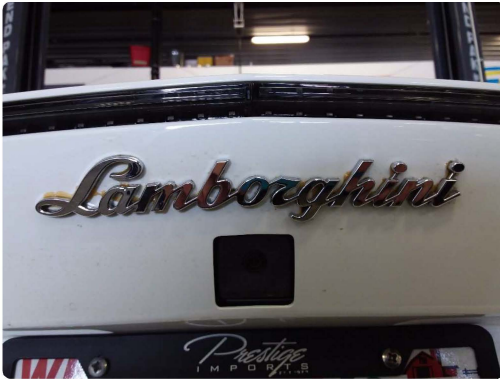
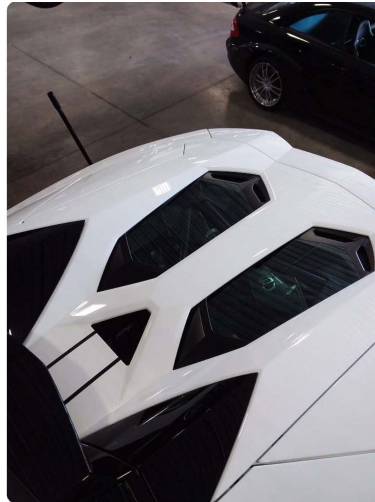
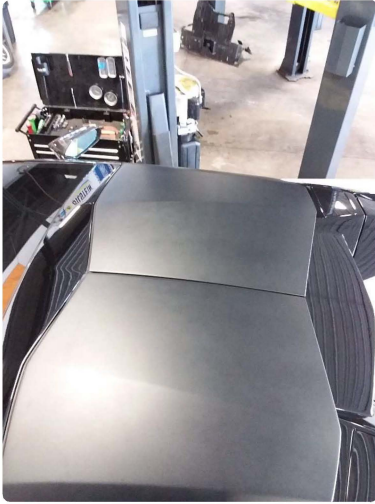
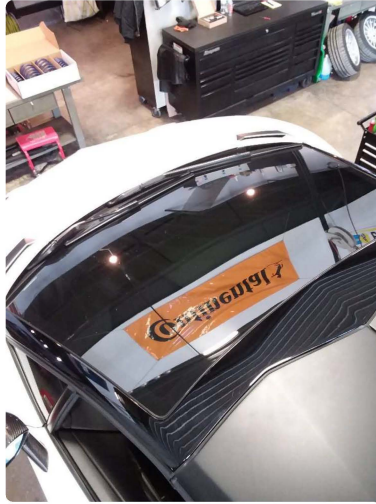
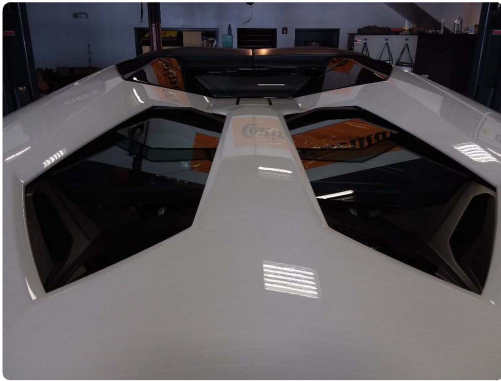
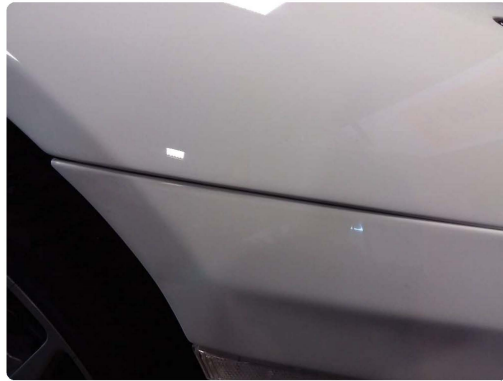
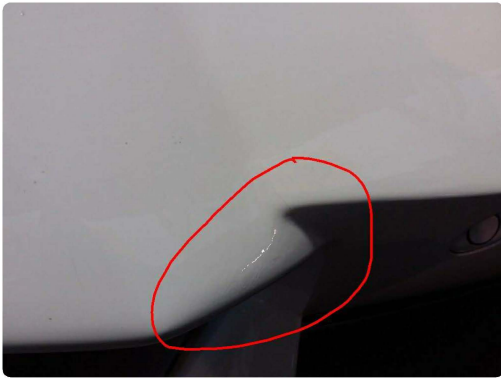
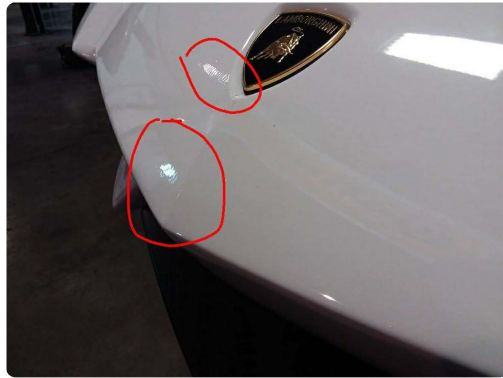
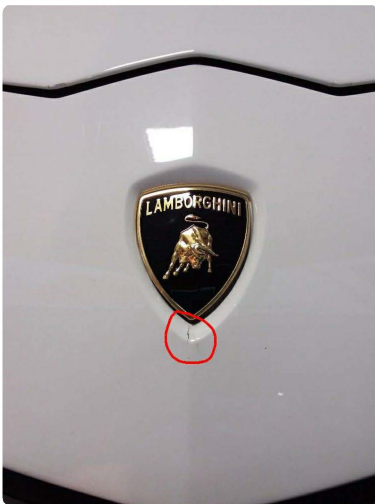
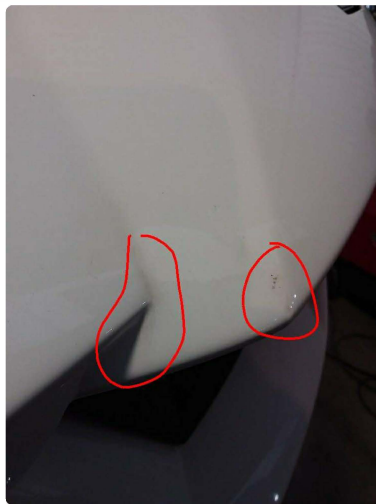
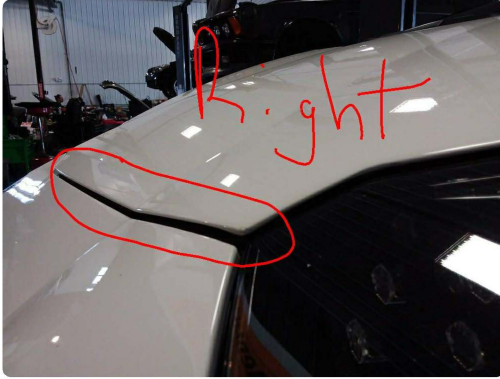
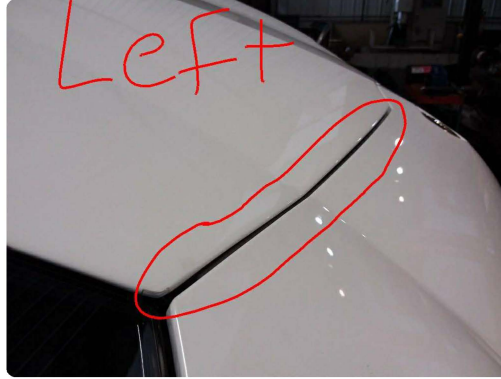
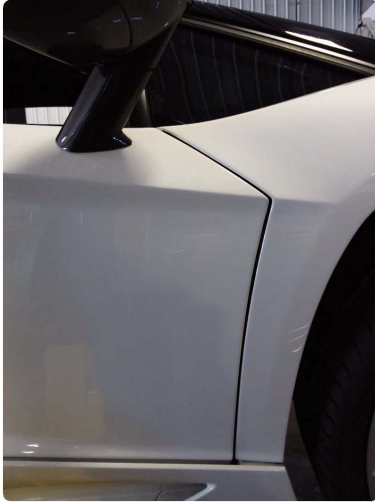
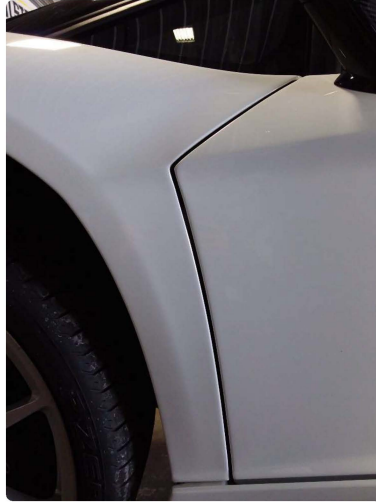
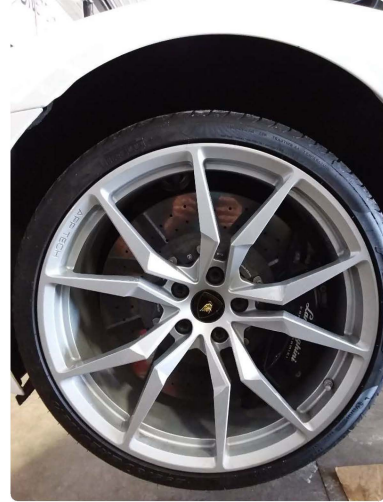
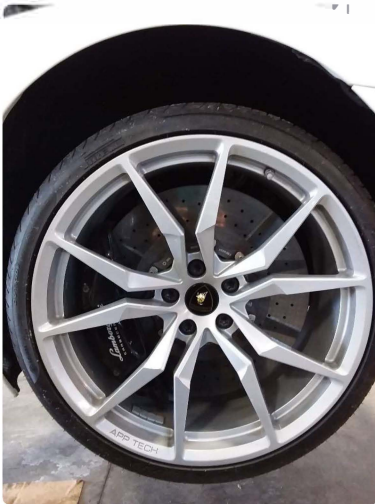
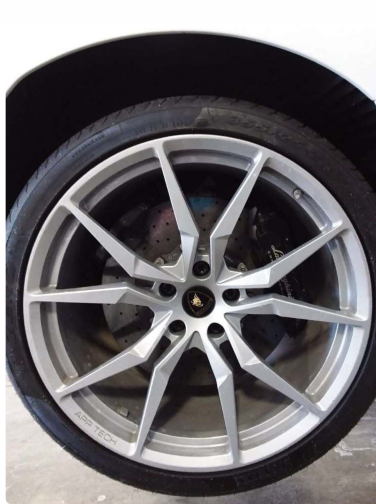
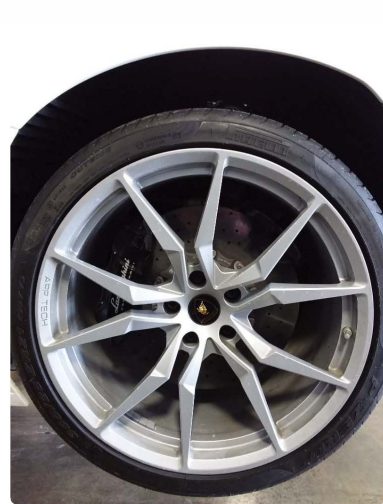
Technician Note: From a visual inspection, it does appear that some areas of the vehicle have been repaired. Meaning either repainted or air brushed in some areas like the following.. -Front bumper - Rear bumper -Hood -Door handles (See pictures and videos) The front bumper has scratches and shows signs of repair/being repainted. Also does not line up with fenders or hood. Underneath is heavily damaged with scraps and scratches (see pictures) The hood appears that it has a clear bra on it. The front fender liners are missing screws/not clipped. The rear bumper has some sections where clear bra was applied. Overall the body does have some imperfections. Small dings and scratches and shows signs of being repainted or air brushed in some places.

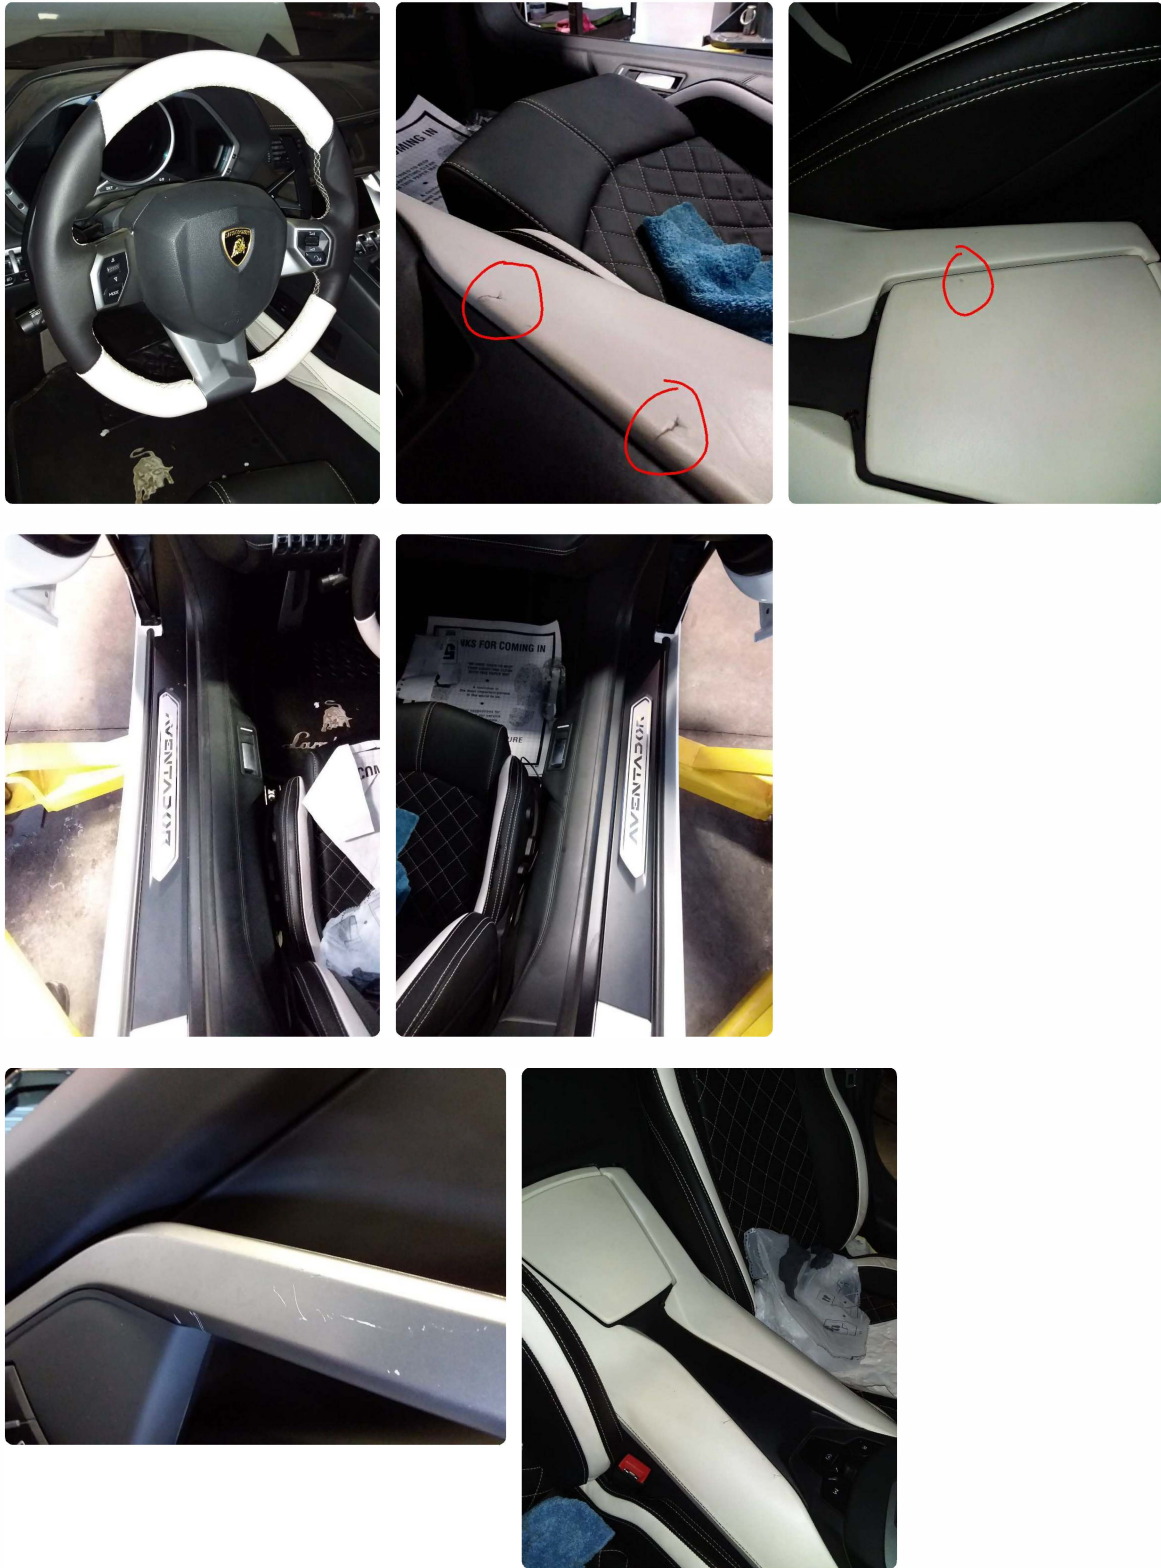
Technician Note: The overall interior condition is fair. It is showing signs of age and use in some areas. Scratches and Nick's in the center console. Wear in the seats Scratches on the door panels

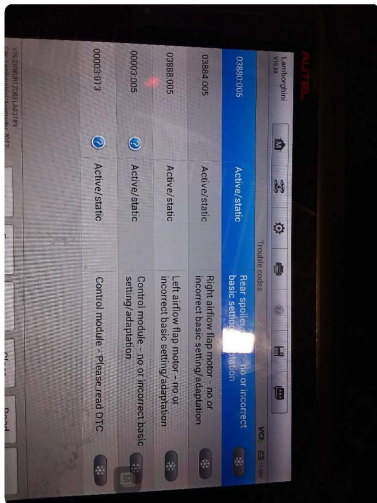
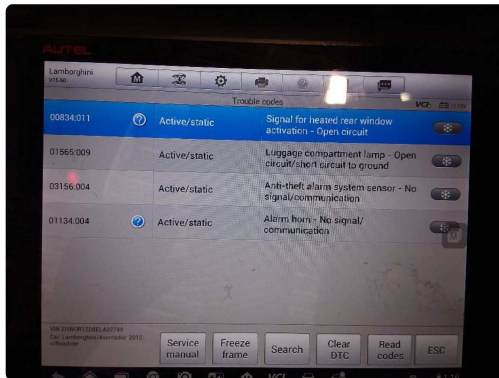
Technician Note: Central Module comfort system has 4 codes Aerodynamics control unit has 5 codes See pictures for description Once the vehicle started we noticed communications codes regarding coding for the aerodynamics module. We also restored the coding for it.

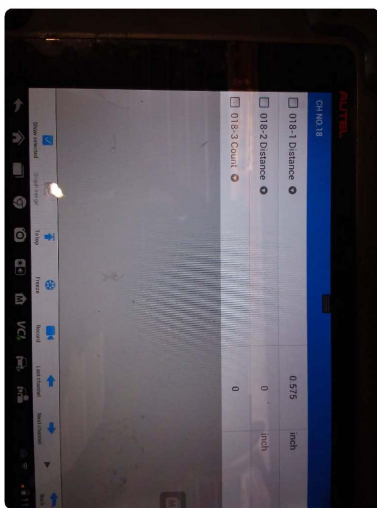
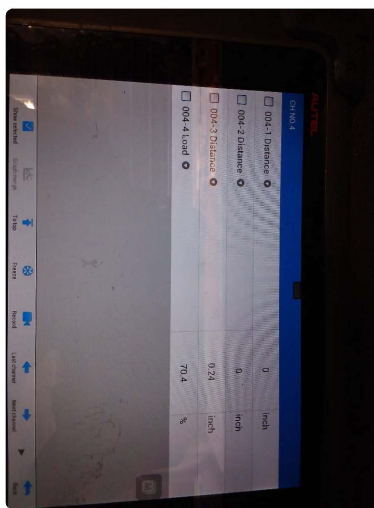
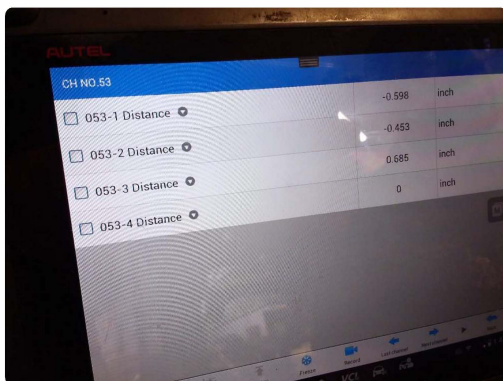
Technician Note: According to the scanner and using the data to find out the percentage. The estimated clutch is at 37% out of 100%

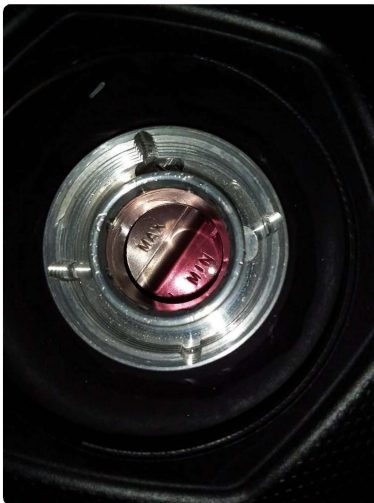
Technician Note: The vehicle engine coolant level is at the correct level and the fluid condition appears normal. Right at the MIN mark

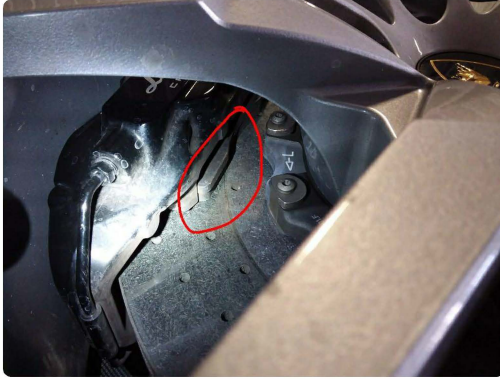
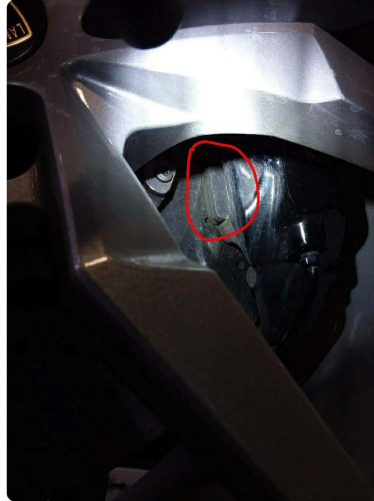
Technician Note: Upon inspection of your rear brakes we found that the brakes are in good shape at this time! Rear Brakes:7mm

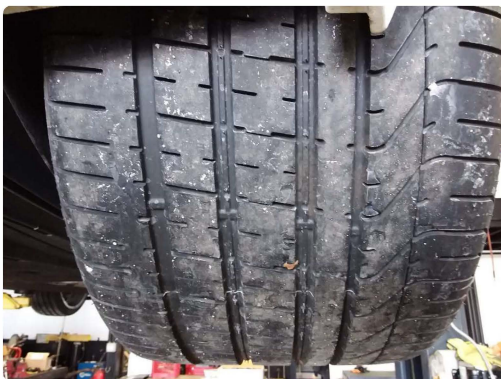
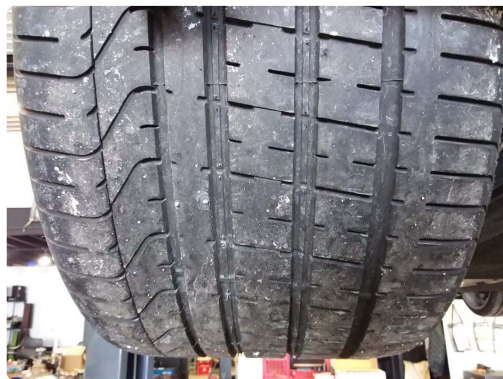
Technician Note: Front left 8/32 Front right 8/32 Rear right 8/32 Rear left 8/32 Right rear tire was manufactured in 2020 Left rear tire was manufactured in 2019 Front right tire was manufactured in 2020 Front left tire was manufactured in 2020

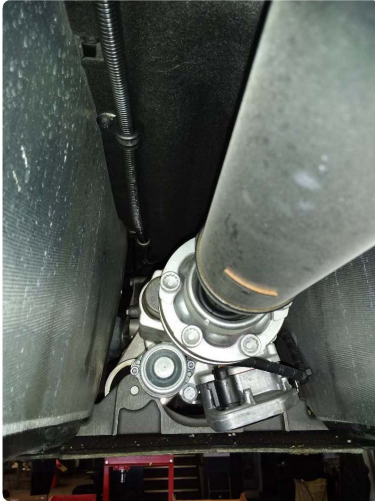
Technician Note: The water pump appeared to have leaked/is leaking. There is dried up coolant on the plug on the water pump. No fresh drips or residue on the undertray. There is oil on the right rear axle but it appears it could be from the oil filter. Possibly not cleaned off from last service. The transmission casing appears to be seeping. (See pictures)
